**Project Example - Guaranteed Performance Based Full Scale Remediation of PCE using ERH under an Operating Shopping Mall, Chicago, IL**

*This was a guaranteed performance based remediation of PCE in clay soil underneath an operating retail shopping mall.*

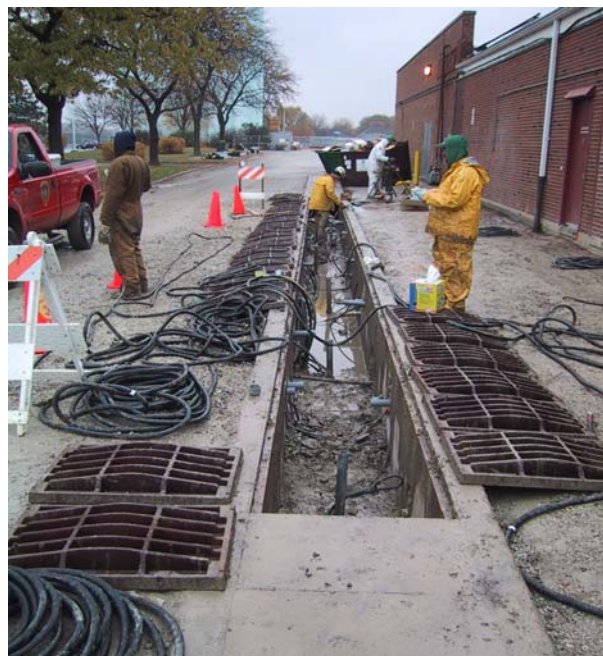
**Figure 1.** Installation of ERH Components in Common Utility Trench

TRS guaranteed that the alley behind the retail shopping mall would remain open to the public during ERH system construction and operations. TRS installed the ERH system components below the alley in rated vaults and in the common utility trench (see Figures 1 and 2). The alley remained open during construction and operations to pedestrians and vehicles.

Site geology consists of clay and silt with a hydraulic conductivity of  $10^{-8}$  cm/sec. The groundwater table is located at 70 feet bgs. The area of remediation was 1,200 square feet and the subsurface heating interval extended from 4 to 23 feet bgs. Figure 1 shows the common utility trench in the alley that ran through the treatment area. TRS used this existing utility trench to install ERH system components. There were no adverse effects on the operating utilities during ERH application.

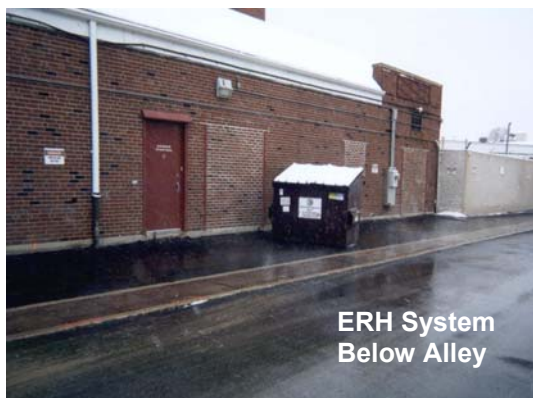
**Figure 2.** The Alley Remained Open during ERH Remediation

TRS was responsible for the design, construction and operation of the full-scale ERH remediation system consisting of 17 electrodes, 4 vertical and 9 horizontal vapor recovery wells, and 3 temperature-monitoring points (TMPs). Figure 3 shows the locations of the ERH components in the alley. The PCE source treated was located in the vadose zone beneath an alley just behind the dry cleaning facility. The alley remained open to vehicle and pedestrian traffic during both the construction and operation of the ERH system. Pedestrians were able to walk directly on top of the electrode array throughout the heating process (Fig. 2).

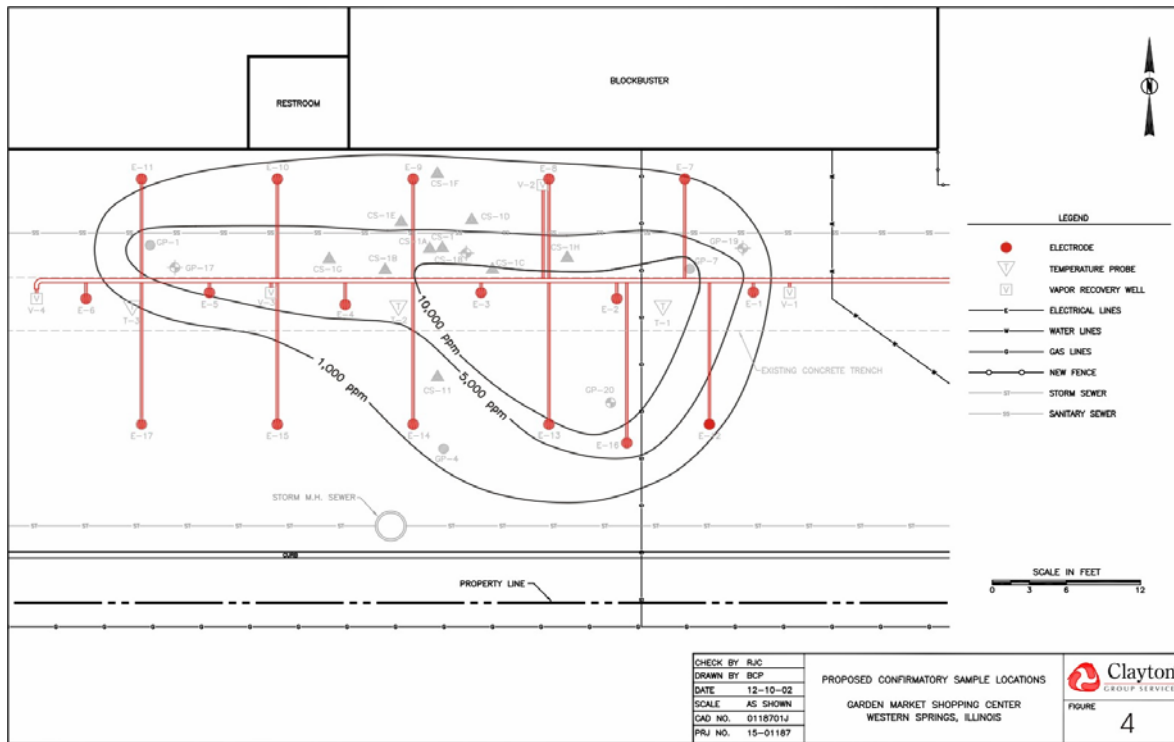
**Figure 3.** Electrode and Conveyance Piping Locations Installed Below the Alley

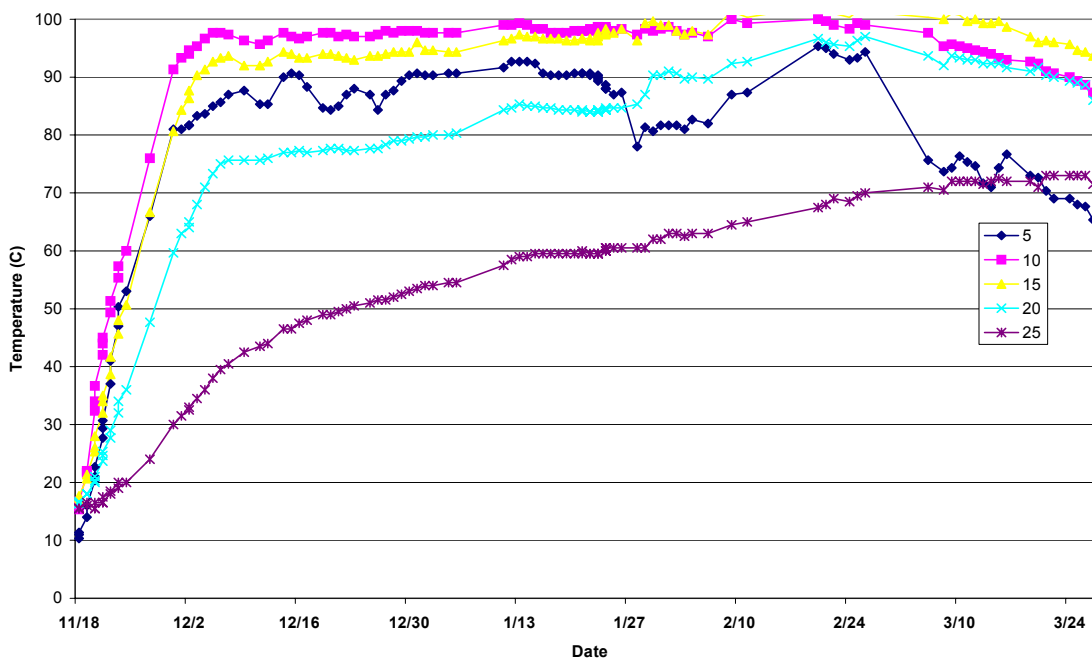
Uniform increases in subsurface temperatures in the remediation area are illustrated in Figure 4 below. The subsurface design temperature was achieved rapidly. Within a couple of weeks from the beginning of ERH operations the boiling point of PCE was achieved (87°C).

**Figure 4.** Subsurface Temperature at Depth over Time

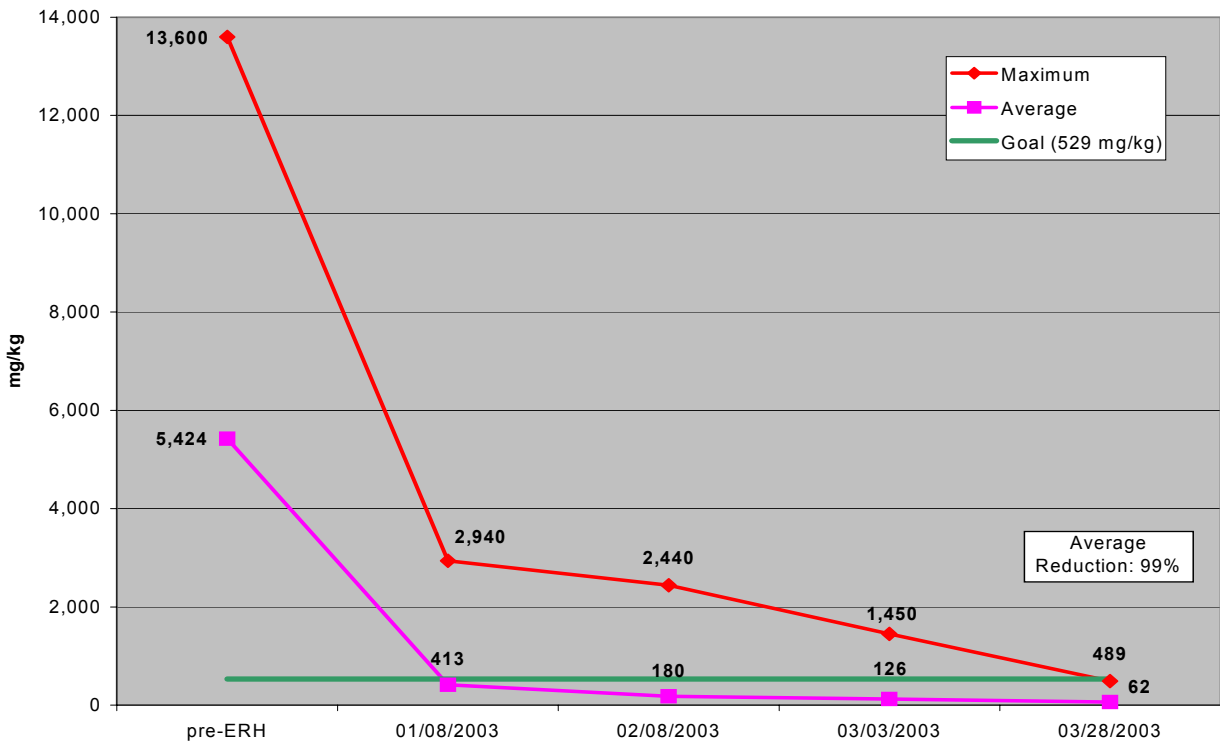
**Figure 5.** Maximum and Average PCE Soil Concentrations vs. Cleanup Goal

Following four months of ERH operations, maximum PCE concentrations in all confirmatory soil samples were below the cleanup goal. The average concentration of PCE in the confirmatory soil samples was 62 mg/kg. Several sampling locations showed reductions in PCE concentrations as high as 98-99.6%. Figure 5 illustrates the maximum and average soil concentrations of PCE achieved during site remediation compared to the site cleanup goal. Confirmatory soil sampling data proved that the site cleanup goal had been exceeded and that the average reduction of PCE in soil was 99%.
