Project Example - Remediation of 1,1,2,2-Tetrachloroethane using ERH at the U.S. Naval Station Annapolis, US Naval Academy, Annapolis, Maryland

This project represents the second project ever implemented involving the remediation of 1,1,2,2-Tetrachloroethane (TeCA) using ERH for heat enhanced hydrolysis.

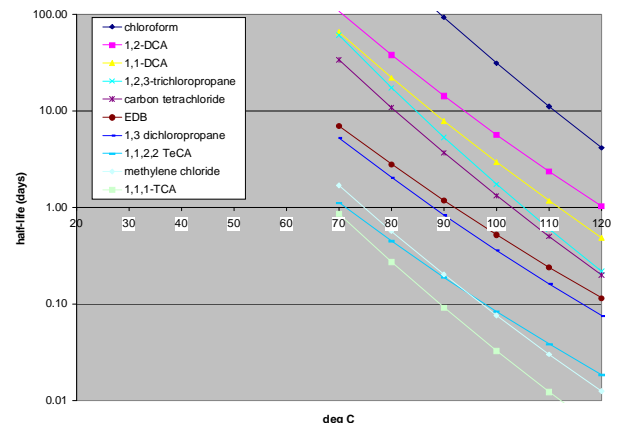
Figure 1. Hydrolysis of Halogenated Alkanes at Elevated Temperatures

TeCA is an interesting compound from a thermal remediation perspective. At elevated temperatures, TeCA rapidly converts to trichloroethene (TCE) through hydrolysis (Figure 1). Hydrolysis is a water substitution reaction; the TeCA hydrolysis reaction is also sometimes referred to as “dehydrohalogenation.” During hydrolysis, TeCA reacts directly with water or soil moisture without regard to redox conditions; no inorganic or biochemical catalysts are required. The conversion of TeCA to TCE proceeds very rapidly when the site begins to heat. For example, the TeCA hydrolysis half-life is less than one day when the subsurface temperature exceeds 75°C (160°F). For this reason, remediation at this site can be considered to be a TCE remediation – the vast majority of the TeCA will convert to TCE and be removed from the subsurface as TCE, with TeCA forming only a small portion of the extracted VOCs. One pound of TeCA forms 0.78 pounds of TCE as determined by chemical stoichiometry.

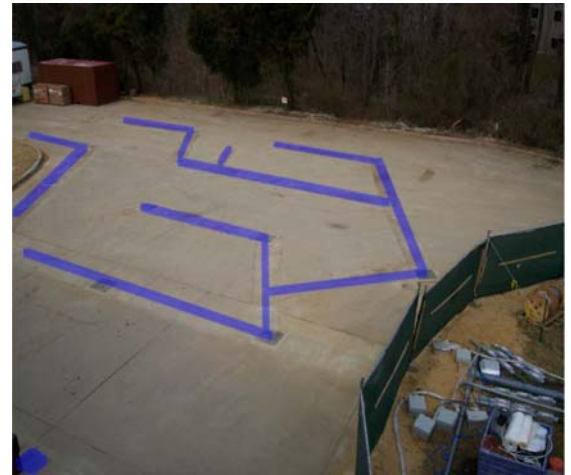
Figure 3. Electrodes and TMPs Installed Below Grade Allowing Unrestricted Access

Construction of the ERH system began on November 7, 2005 with the placement of the surface equipment, which included the Power Control Unit (PCU), steam condenser, cooling tower and vapor recovery blower. Subsurface installation of the electrodes began the following week on November 16, 2005 and was concluded on January 17, 2006. The installation of the surface equipment and completion of the trenches that supply power and vapor recovery to the electrodes was completed the following week on January 25, 2006. Figure 3 shows the locations of the below grade electrodes, TMPs, piping and cables outlined with blue lines.

The ERH remediation area required below grade completion of the electrodes, cables and piping to allow unrestricted access by pedestrians and vehicles during operations behind the Navy Commissary building (see Figure 3).

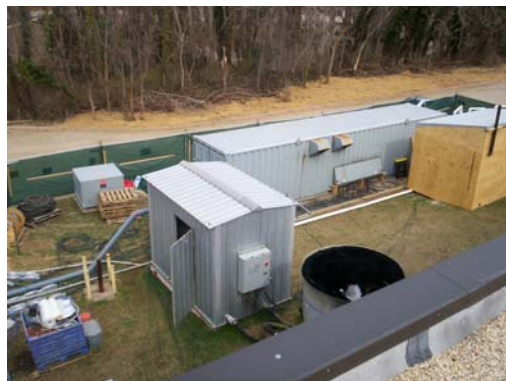
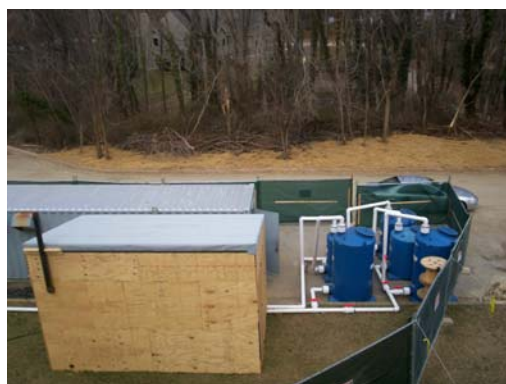
Figure 4. ERH Equipment Compound with Sound Enclosure (plywood) around Blower

The ERH system became fully operational on Friday, January 27, 2006. On April 20, 2006, the average subsurface temperature was 98.6°C. Figure 4 shows the equipment compound. The PCU, steam condenser, air cooling tower and vacuum blower are shown in the top picture. The vacuum blower is inside a plywood sound enclosure. The Granular Activated Carbon (GAC) canisters (blue containers) are to the right of the blower and PCU in the lower picture.

During ERH operations, a local resident about 100 feet away from the remediation area, complained about the sound of the vacuum blower. TRS immediately built a sound

enclosure made from ¾-inch plywood sheets around the blower that proved successful at reducing the sound to an acceptable level (see Figure 4).

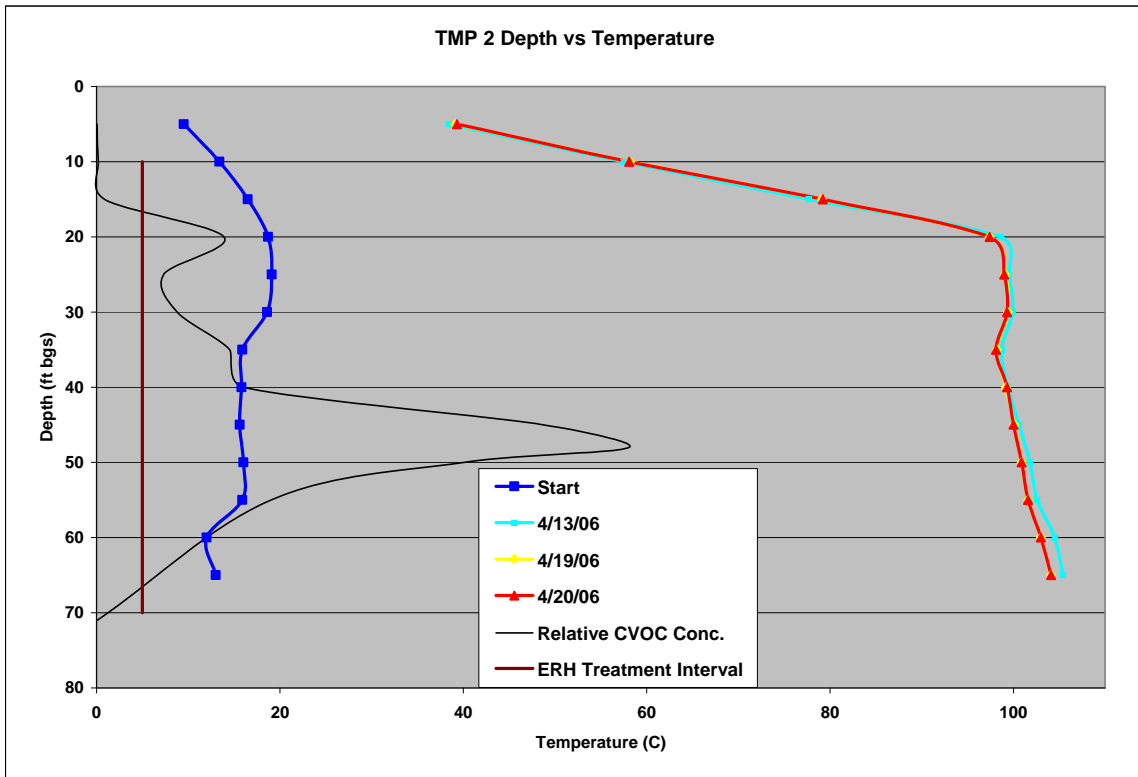
Figure 5. Subsurface Temperature at Depth vs Relative CVOC Concentration at TMAP 2

Figures 5, 6, and 7 illustrate the subsurface temperatures for TMP locations 2, 4 and 5 over time from the initial baseline temperature on January 27, 2006 through April 20, 2006. The average subsurface temperature for each TMP does not include its 5 or 75-foot interval temperature as they are located outside the treatment area. The depth of treatment corresponding to each TMP has been included as well as the relative CVOC concentration for reference.

In Figures 5, 6 and 7 notice the correlation between the elevated subsurface temperature and the location of the relative contaminant concentrations. The black line represents the relative concentration of CVOCs. The brown line represents the ERH treatment interval. The blue line represents the start of ERH operations. Each of the other colored lines represents the subsurface temperatures at depth on a given day.

These Figures illustrate that the area of highest contaminant concentration is also the location of elevated subsurface temperatures as designed. This is expected because the electricity flows preferentially to low resistance pathways or areas of higher conductivity. As the TeCA undergoes heat-enhanced hydrolysis and converts to TCE, chloride ions break away from the degrading TeCA and create a chloride ion halo surrounding the contamination resulting in areas of higher conductivity. The areas of higher conductivity heat up slightly faster than the surrounding soil. As the TeCA converts to TCE by heat enhanced hydrolysis, the TCE is recovered in the vapor phase.

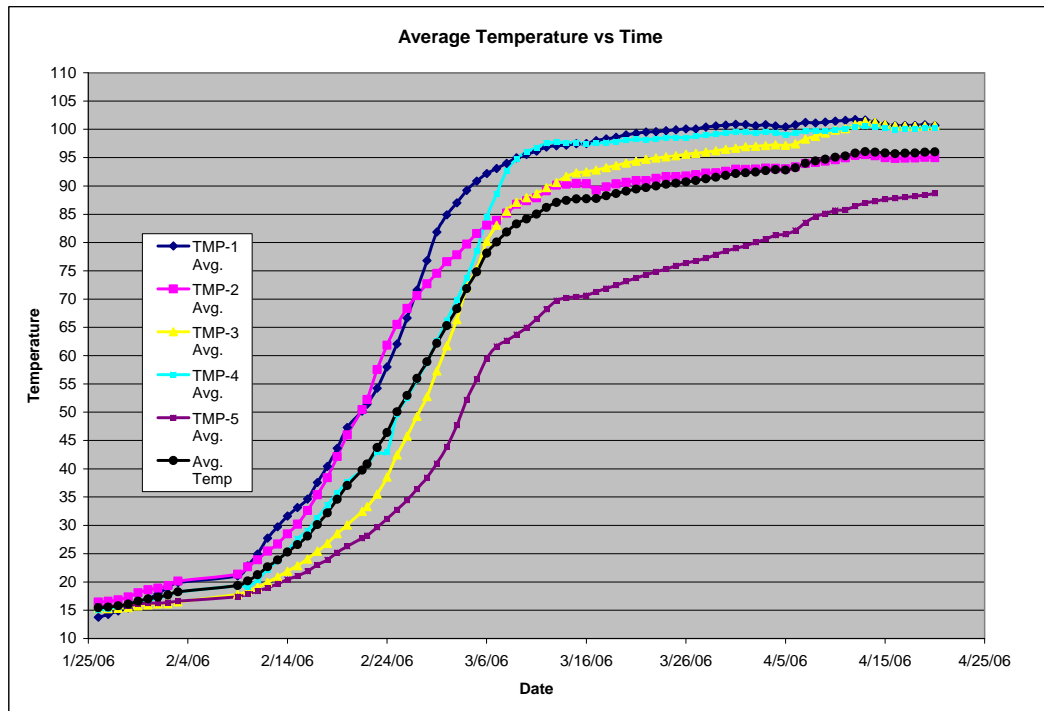
Figure 8. Average Subsurface Temperatures vs Time

Figure 8 illustrates the combined average subsurface temperatures at TMPs 1-5 from January 25 through April 20, 2006.

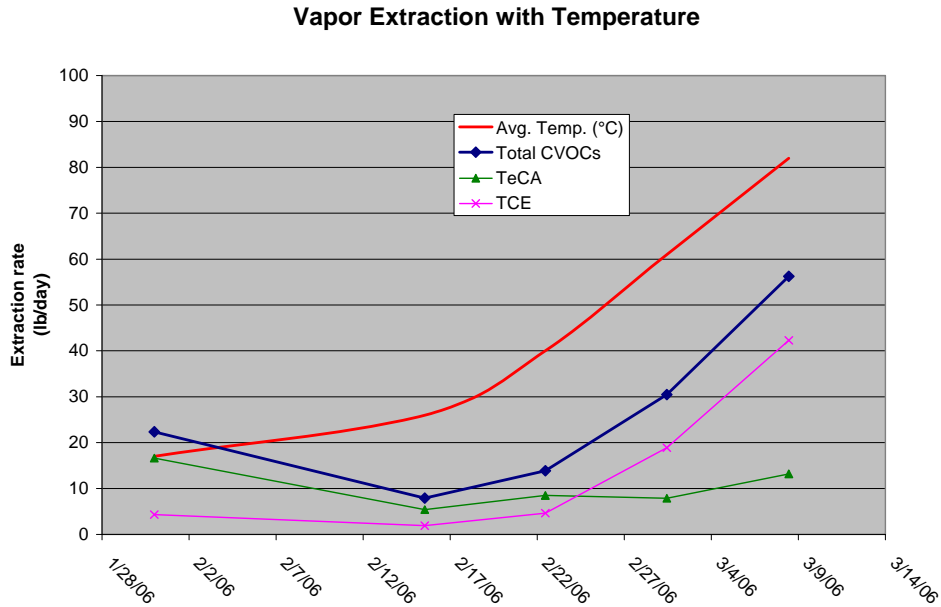
Figure 9. CVOC Extraction Rate (pounds per day) with Temperature over Time

Figure 9 illustrates the vapor recovery of TeCA, TCE and total CVOCs in lbs per day during the ERH remediation from January – March 2006.

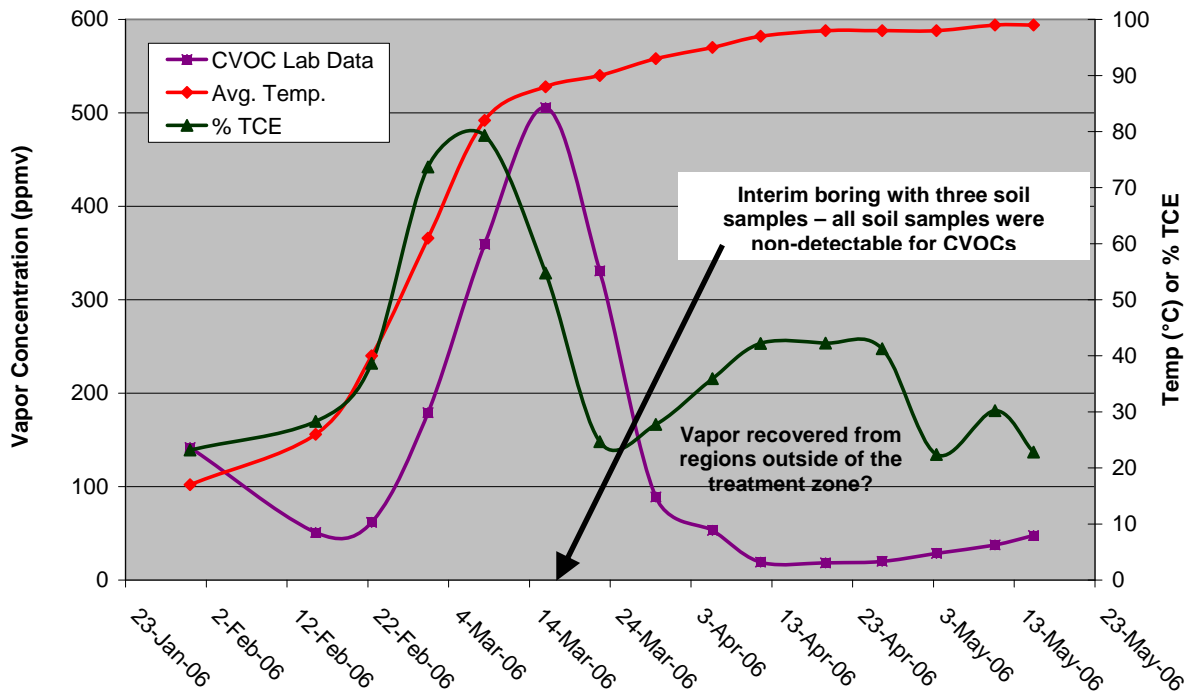
Figure 10. Recovery of Total CVOC (purple line) vs TCE (green line) with Temperature over Time

Figure 10 illustrates the recovery of total CVOCs compared to the recovery of TCE with subsurface temperature during the ERH remediation. In March 2006, less than two months following startup, interim soil samples were collected inside the treatment region. All three interim soil samples were non-detect (ND) for CVOCs. Following the interim event, TRS continued to recover TCE vapors (green line in Figure 10) for a few more months which implores the question, were the TCE vapors coming from a region outside of the treatment area.

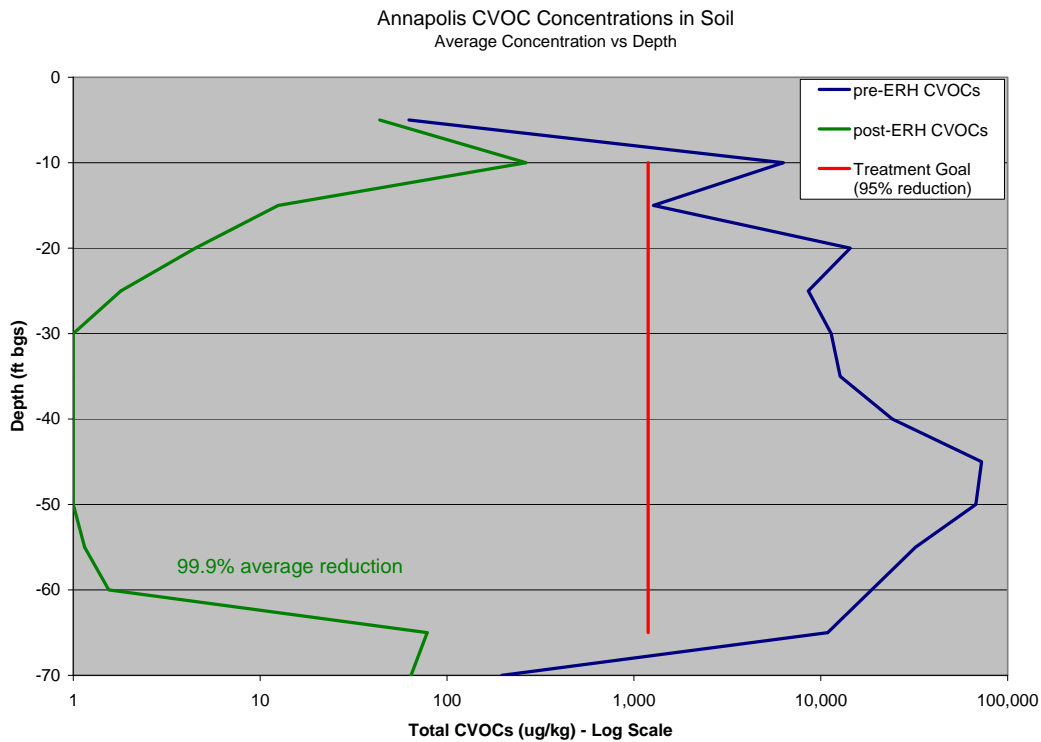
Figure 11. Average Concentrations of Total CVOCs at Depth Pre and Post ERH

Figure 11 illustrates the average concentrations of CVOCs at depth before and after ERH compared to the remedial goal. The remedial goal was an average 95% reduction in total CVOCs in soil. The confirmatory soil sample results, collected on 2/15/07 approximately one year following the interim sampling event, showed an average 99.9% reduction in total CVOCs in soil.
