COST AND PERFORMANCE REPORT

Electrical Resistive Heating at the ICN Pharmaceutical Site Portland, OR

Technology: Electrical resistive heating (ERH)

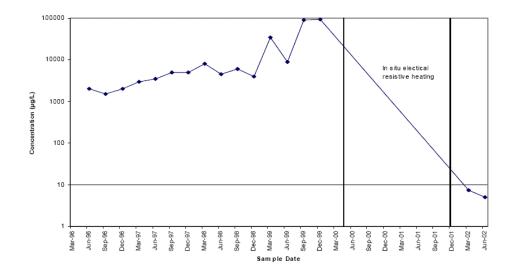
Figure 2. ICN Site: cis-1,2-DCE Concentrations in Source Zone (MW-28) May 1996 - June 2002 (log scale) [1]

Figures 2 through 5 show the concentrations of DCE over time in the source zone (intermediate well MW-28 and deep well MW-31), the treated area outside the source zone (MW-25), and downgradient from the treated area (MW-53). As shown in these figures, DCE concentrations in the source zone treatment area wells decreased following ERH treatment of the source, with the concentrations in the downgradient wells remaining relatively level.

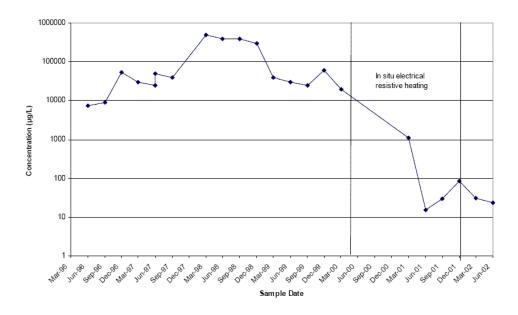
Figure 3. ICN Site: cis-1,2 DCE Concentrations in Source Zone (MW-31) May 1996 - June 2002 (log scale) [1]

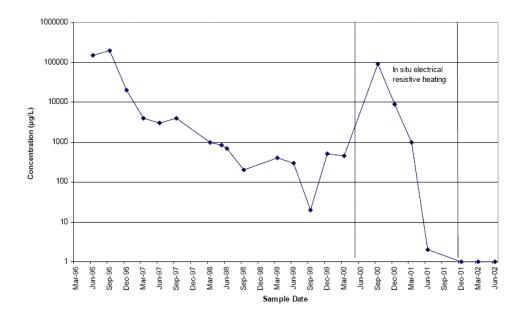
Figure 4. ICN Site: cis-1,2-DCE Concentrations in Treatment Area (MW-25) May 1996 - June 2002 (log scale) [1]

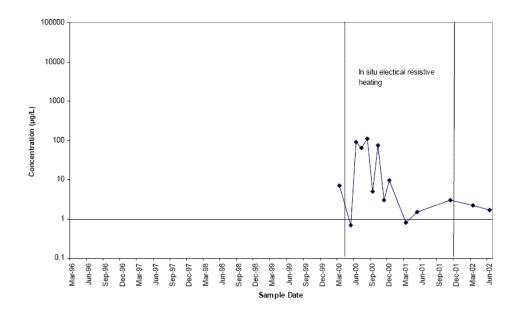
Figure 5. ICN Site: cis-1,2-DCE Concentrations in Downgradient Area (MW-53) May 1996 - June 2002 ((log scale) [1]
